Technical Preservation Services
Preservation Assistance Division
National Park Service
U.S. Department of the Interior
Washington, D.C.

Interpreting the Secretary of the Interior's Standards for Rehabilitation

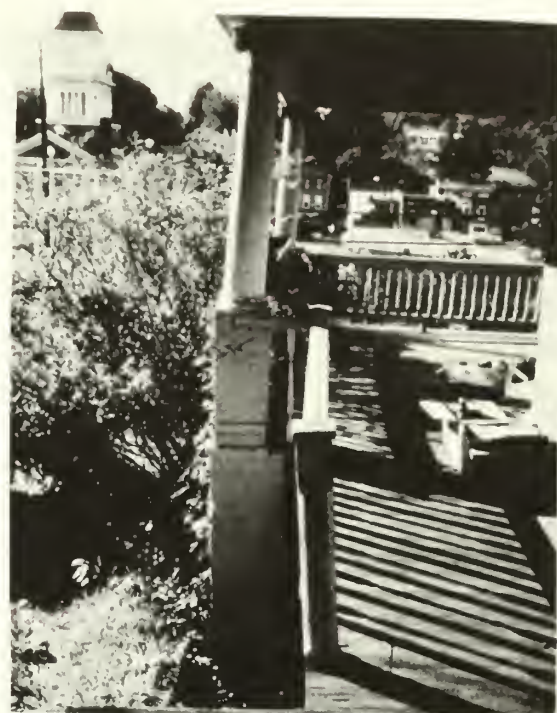
6. A detail of the 1910 porch shows structural problems that need to be corrected. The owner assessed the 1910 front porch as unrepairable, which led to its removal.

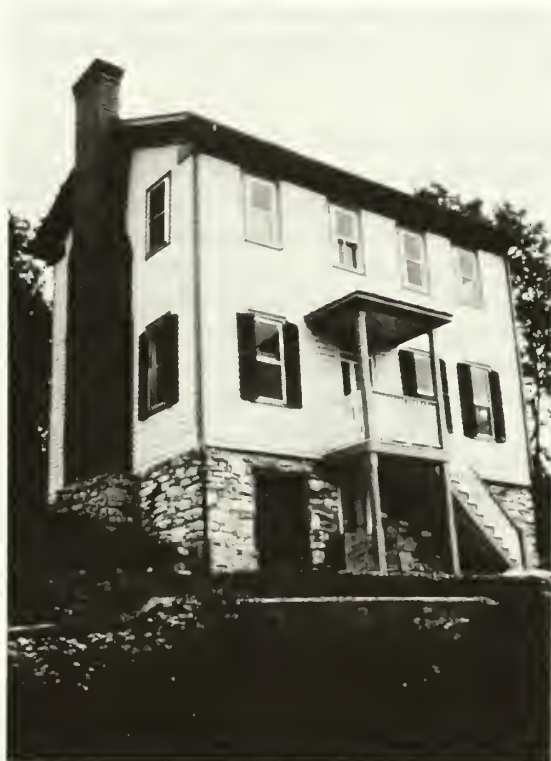
7. The replacement front porch--conjectural in design--was constructed after demolition of the historic porch. NPS concluded that because the 1910 porch was an important character-defining feature and was repairable, it should have been retained. The project was denied certification of rehabilitation for tax benefits.

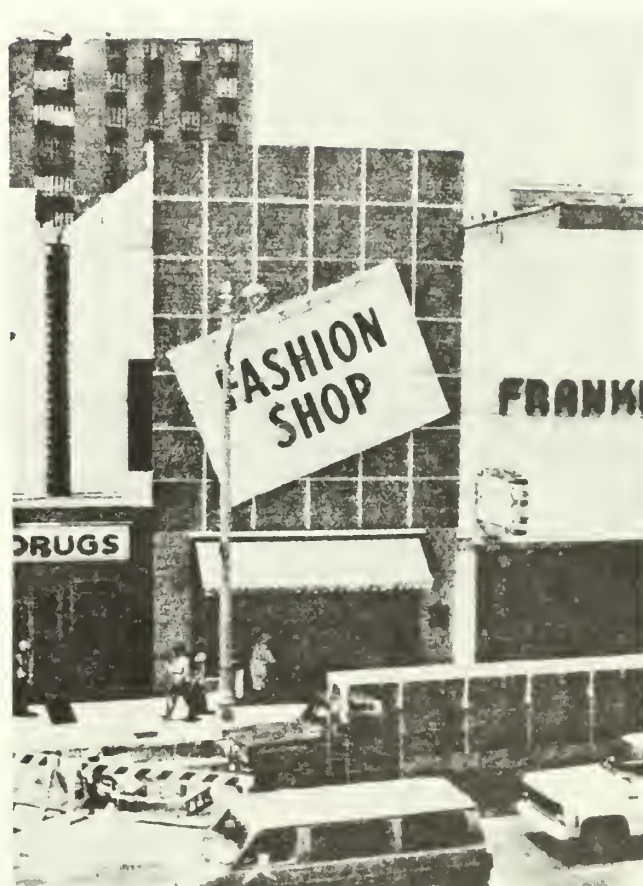
2. A 1967 storefront alteration involved installation of a stucco false front on the upper levels; stone at the ground level had been removed as the result of the installation of an aluminum and glass entry in the 1950s.

Application: A ca. 1870 stone Gothic Revival structure (see illus. 1) was being rehabilitated for re-use as an office building. A 1967 "modernization" of the building's facade for retail use had involved installation of a stucco false front on the upper level of the building. When the false front was subsequently removed as part of the new work, the owner found that the castellated stone at the top of the building had been removed; the historic decorative bands had been chipped away to permit installation of the stucco work; the window sills and jambs were damaged; and several holes had been bored into the stone to anchor the false front. Stone on the ground level of the building had been removed as the result of a 1950s installation of an aluminum and glass entry and merchandise and display area (see illus. 2 and 3).

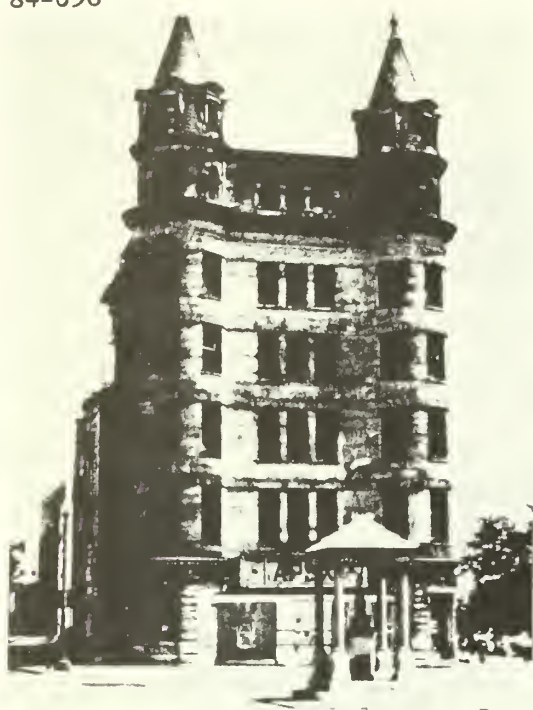
1. This photograph of the west elevation shows the 1880 addition of flush ashlar brownstone above the rough-cut brownstone of the first floor. Because the historic brownstone on this wall was basically sound, only repainting was required.

Application: An 1860s rusticated ashlar brownstone commercial building, altered in 1880 with the addition of a flush ashlar brownstone facade on the west, was purchased for rehabilitation for office use (see illus. 1). The building had been derelict and vandalized for several years—in addition to the total lack of maintenance—and, as a result, was severely damaged and deteriorated. Within the three exterior walls (south, west, and north), which consist of 14-inch thick loadbearing masonry of two wythes of brick faced with brownstone, the mortar was failing between the brick and the stone. The brownstone was spalling on both the north and south walls, with the condition much worse on the north (see illus. 2 and 3). The building had been painted in the past, possibly in an effort to stop water penetration. On the interior, the majority of the distinguishing architectural detailing had been removed as a result of deterioration,

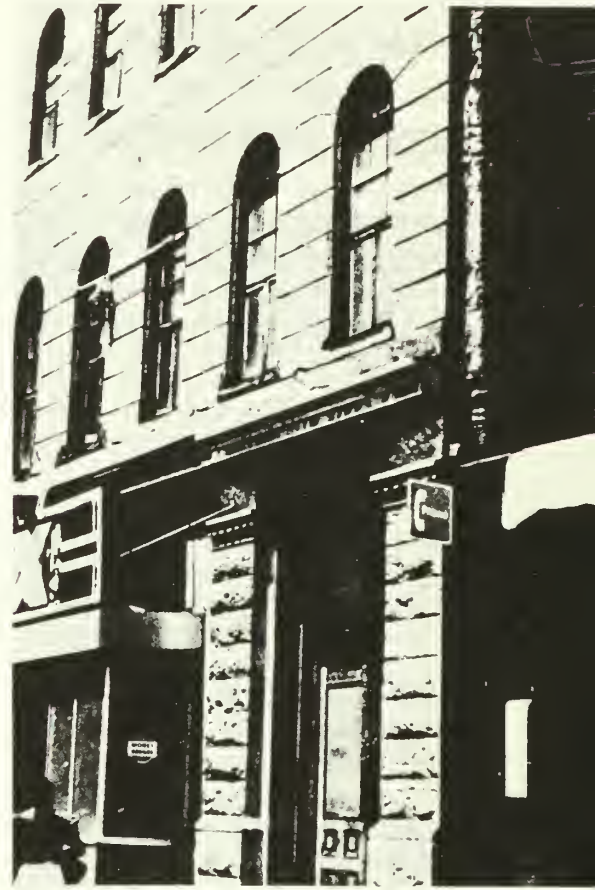
2. The brownstone of the south wall was not as deteriorated and could be retained in place and structurally strengthened by stainless steel pins tying cementitious patches to the sound stone beneath. Limiting the patching to the beveled edges of the stone blocks where the greatest amount of deterioration had occurred was considered a sensitive preservation solution because it left the historic material both intact and visible.

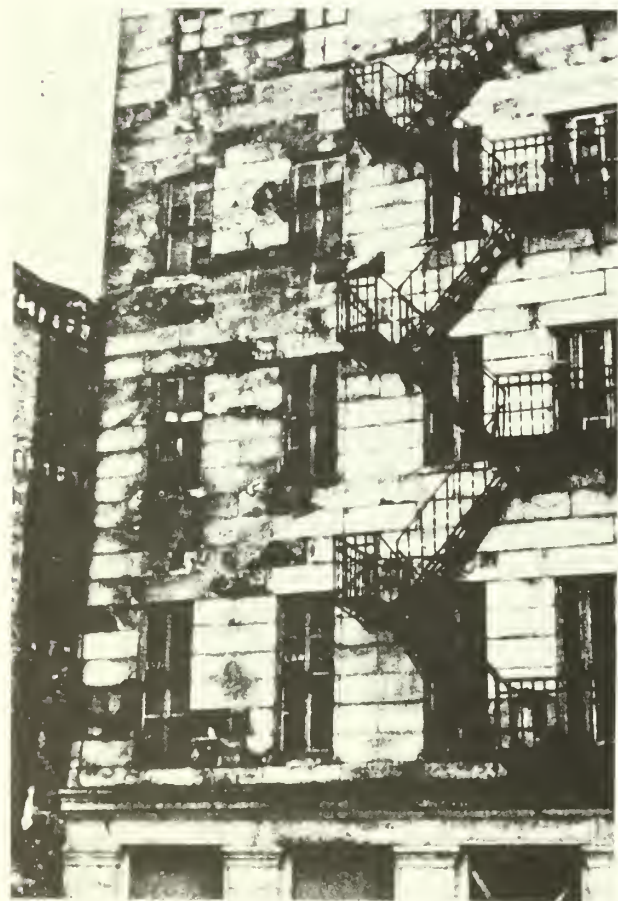
3. Badly spalling brownstone on the north, and less visible, wall was for the most part unsalvageable. Replacement walls were constructed from the second story up, a solution that assured maximum retention of historic material while making the building structurally sound for the new use.

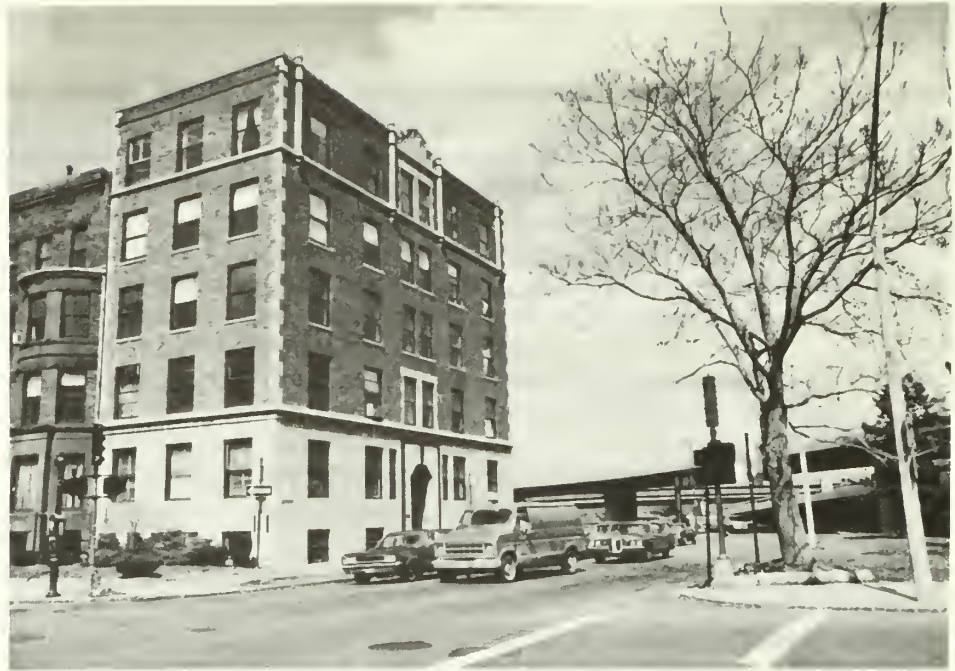
1. This 20th century building served as an anchor at the end of the small historic district and had three highly visible facades. Note how the location, design, and even the color of the wooden sash and frames matched that of the adjacent older properties.

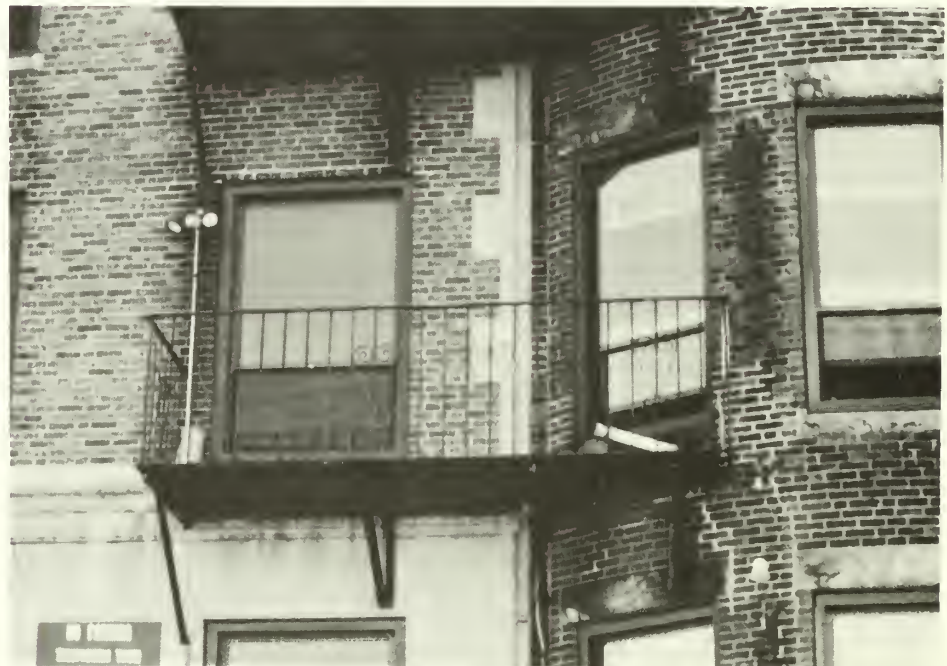
2. This is a close-up view of the contemporary window units which were installed. They had flat framing detail, bronze-anodized finish, tinted glass, and a lowered meeting rail.

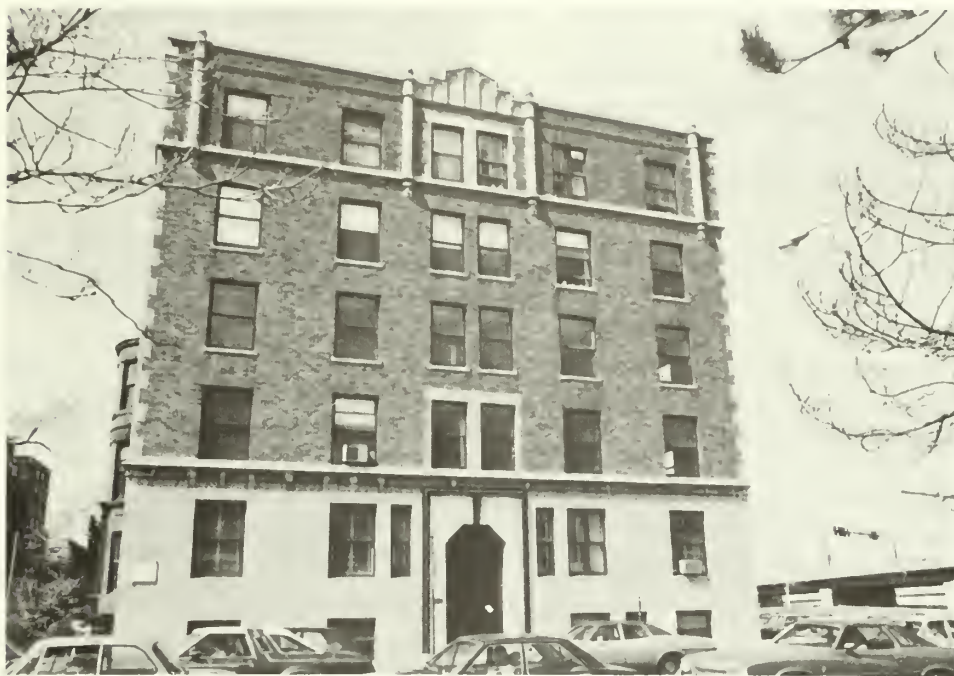
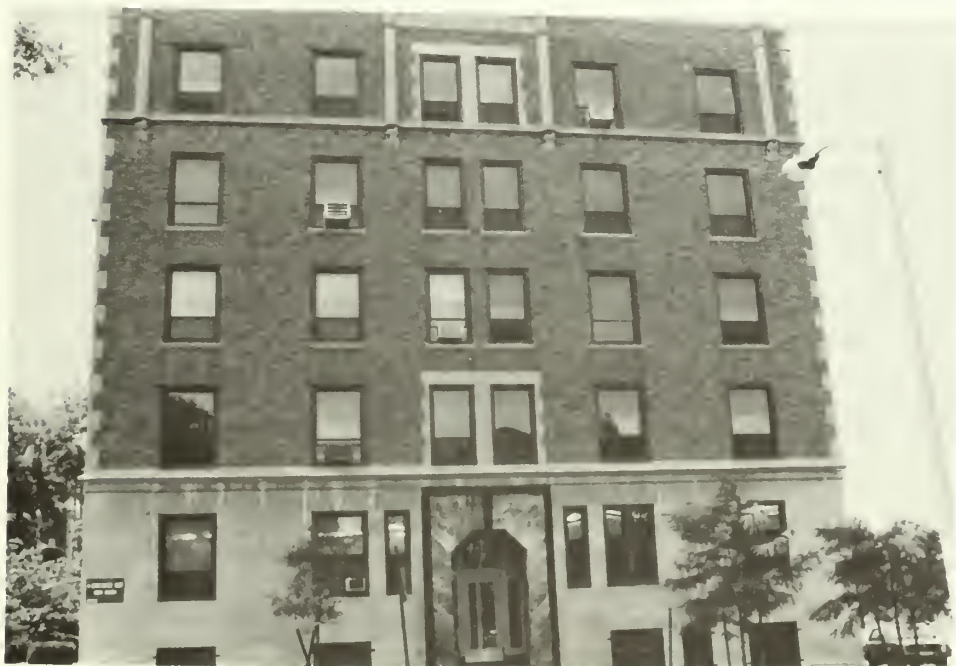
3. Below is a comparison view of "before" and "after" rehabilitation which shows the impact of the window changes. While relocation of the meeting rail was the most pronounced alteration, the tinted glass, lack of trim around the frames, increased width of the anodized aluminum frames, and loss of other detail were cited in denial of the project for preservation tax benefits.

...The historic windows, with clear planes in a 1/1 configuration contributed to the restrained character of the building. "Before" photographs show all of the 1/1 windows in place, and no documentation was provided with the Part 2 application to show that the existing units could not have been repaired and retained. Had replacement proven necessary, the appropriate treatment would have been to use new units which matched the configuration, color, and other visual qualities of the historic windows. Instead, the replacement windows selected employ a lowered meeting rail (in a 2/3 to 1/3 configuration) and tinted glass. As a result, the replacement windows are incompatible with and detract from the historic character (see illus. 3).

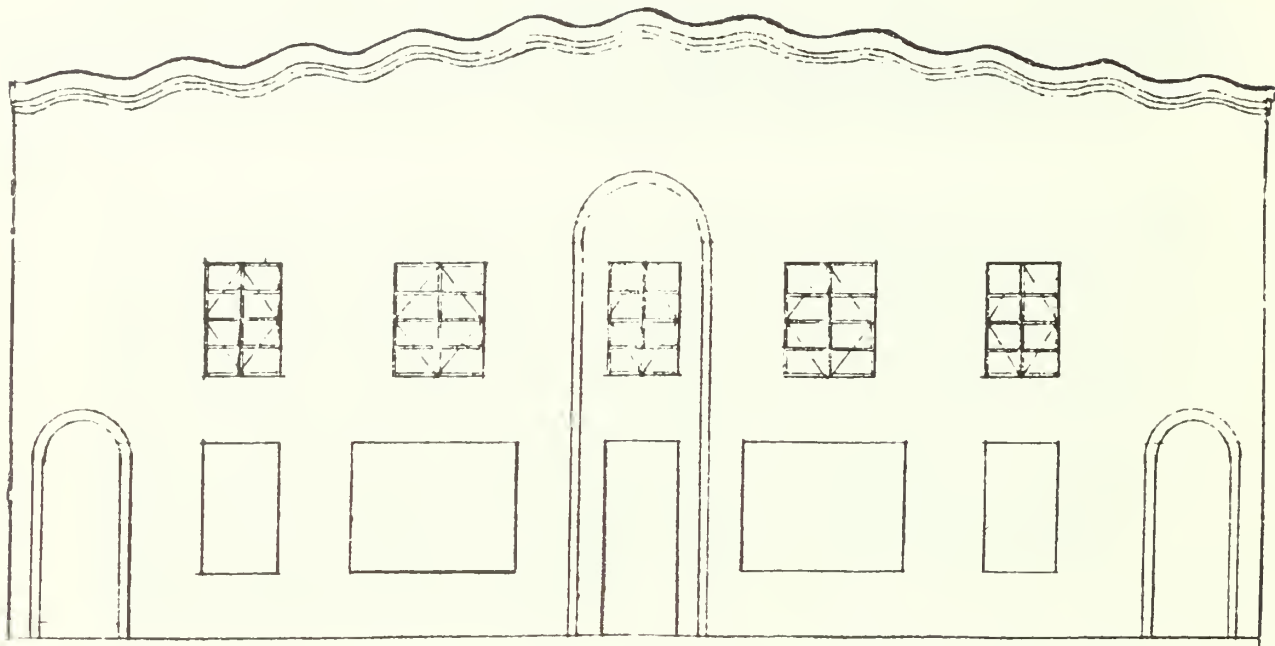
1. This drawing points out the historic form of a small-scale Spanish Colonial Revival building with a waved parapet cap and symmetrical window and door openings.

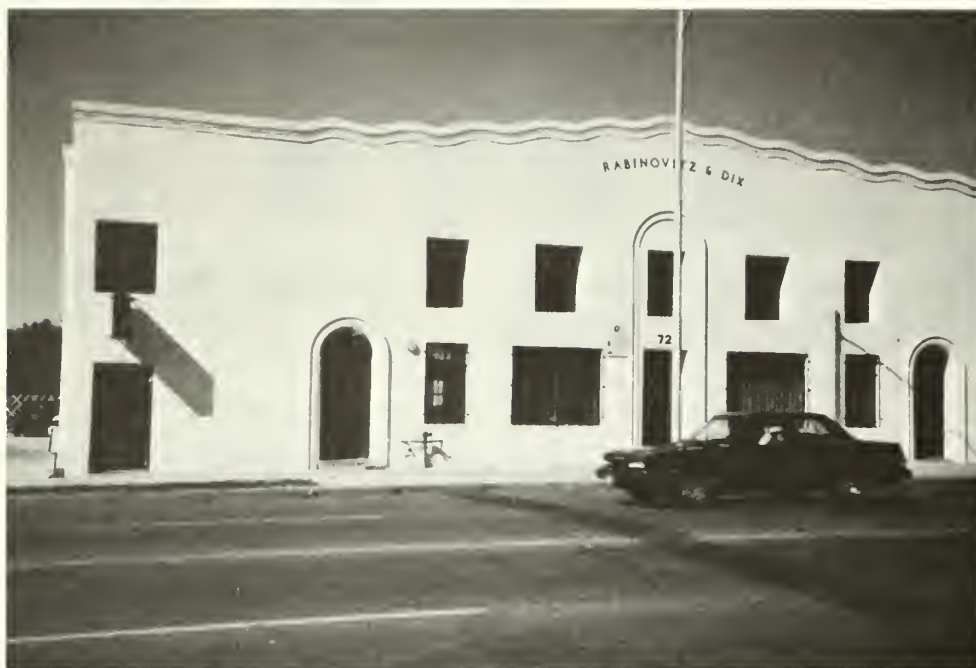
2. This view of the southeast corner of the primary elevation shows the new addition that enclosed an existing stair. The addition extends from the termination of the historic building, which is defined by the waved parapet cap.

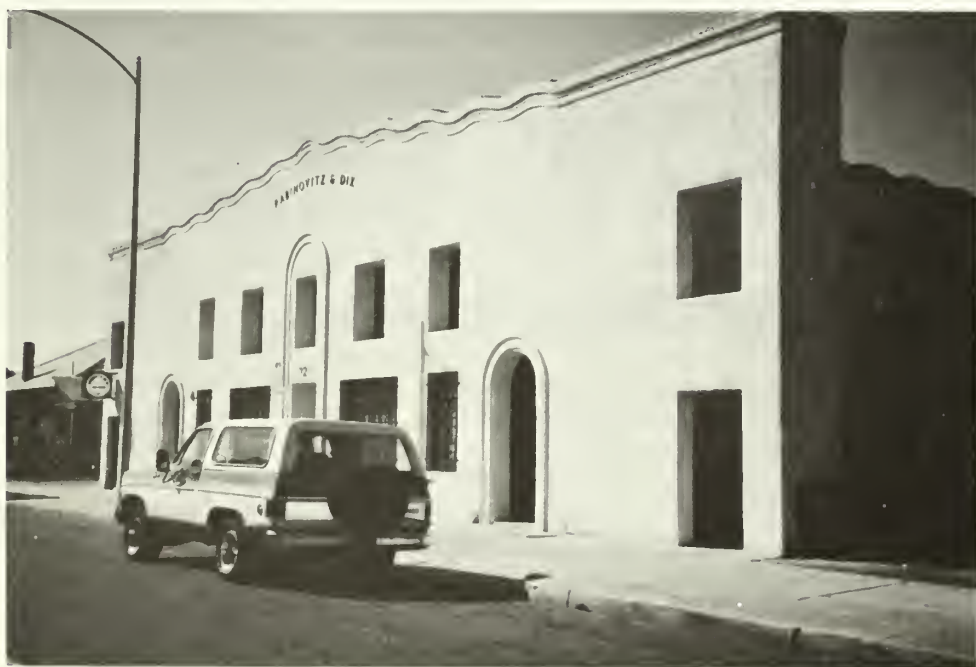
3. This view of the northeast corner of the primary elevation shows the added wing wall that was built to visually balance the new addition on the southeast corner. Again, the addition extends from the end of the historic building, as defined by the waved parapet cap. Both additions increased the total length of the historic building by one-third and made indistinguishable what was historic and what was new construction.

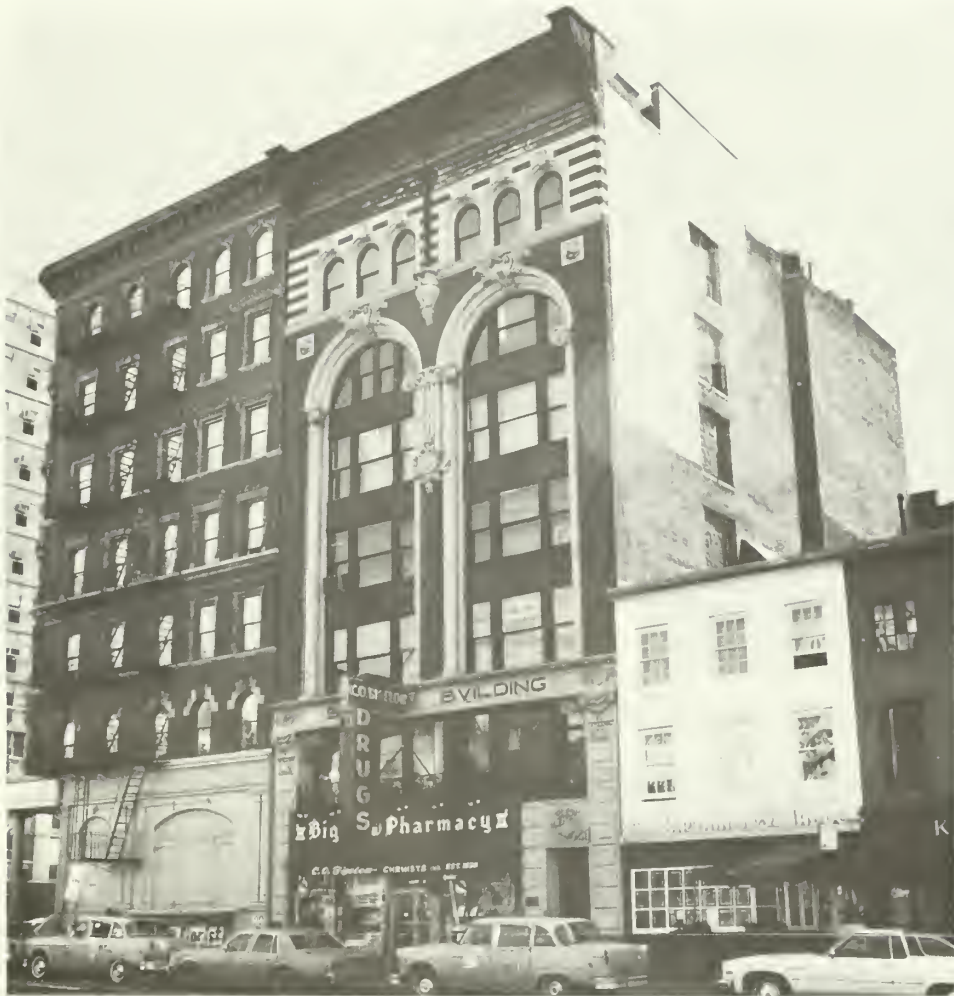
1. Rehabilitation project work on an early 20th century building focused upon meeting health and safety code requirements for the new use.

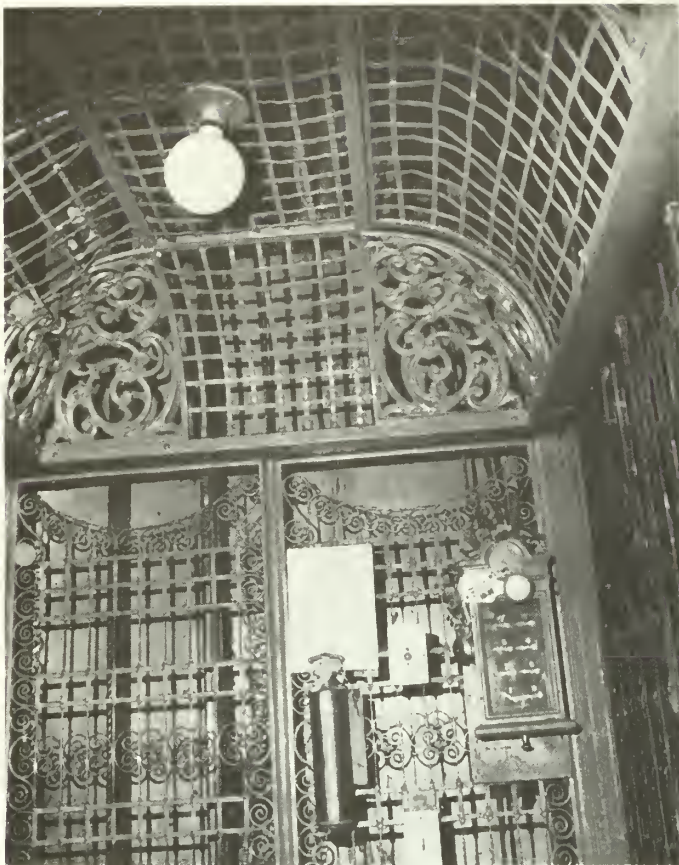
2. This shows a detail of the open dome, manually-operated elevator with its highly decorative iron grill work. Because an enclosed cab was required by State law, the historic elevator was found to be in violation of ANSI building code standards. The consulting engineer thus recommended its removal and replacement with a modern elevator.

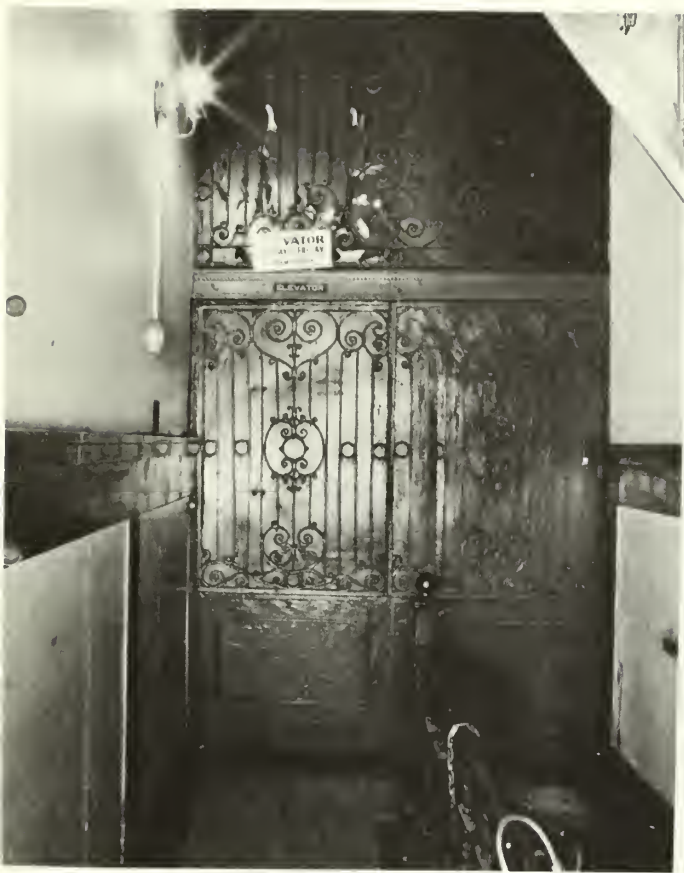
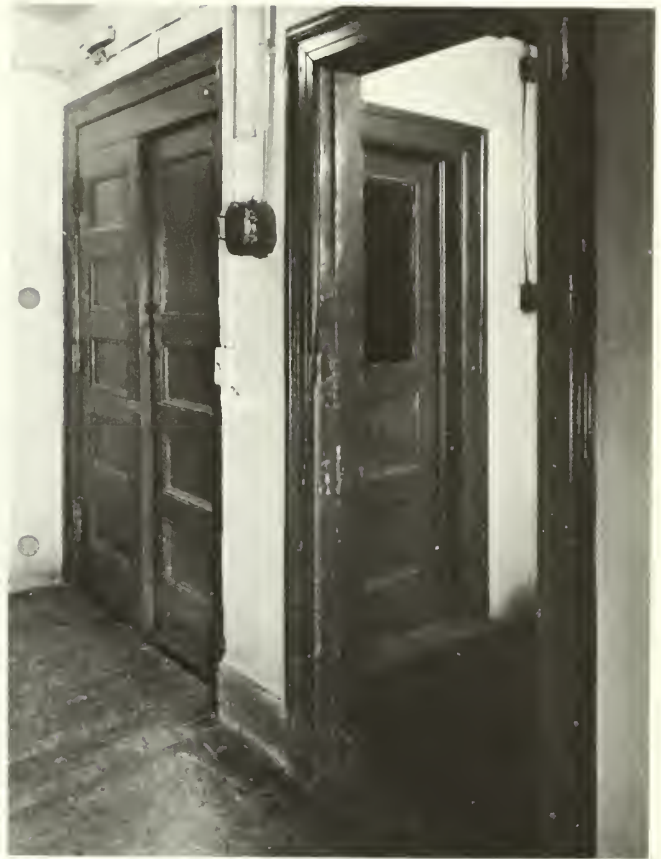
4 and 5. The decoratively detailed elevator doors in the lobby (left) were to be removed as part of the code-required elevator replacement as well as the simpler, panelled doors on floors 3-7 on the west side (right).

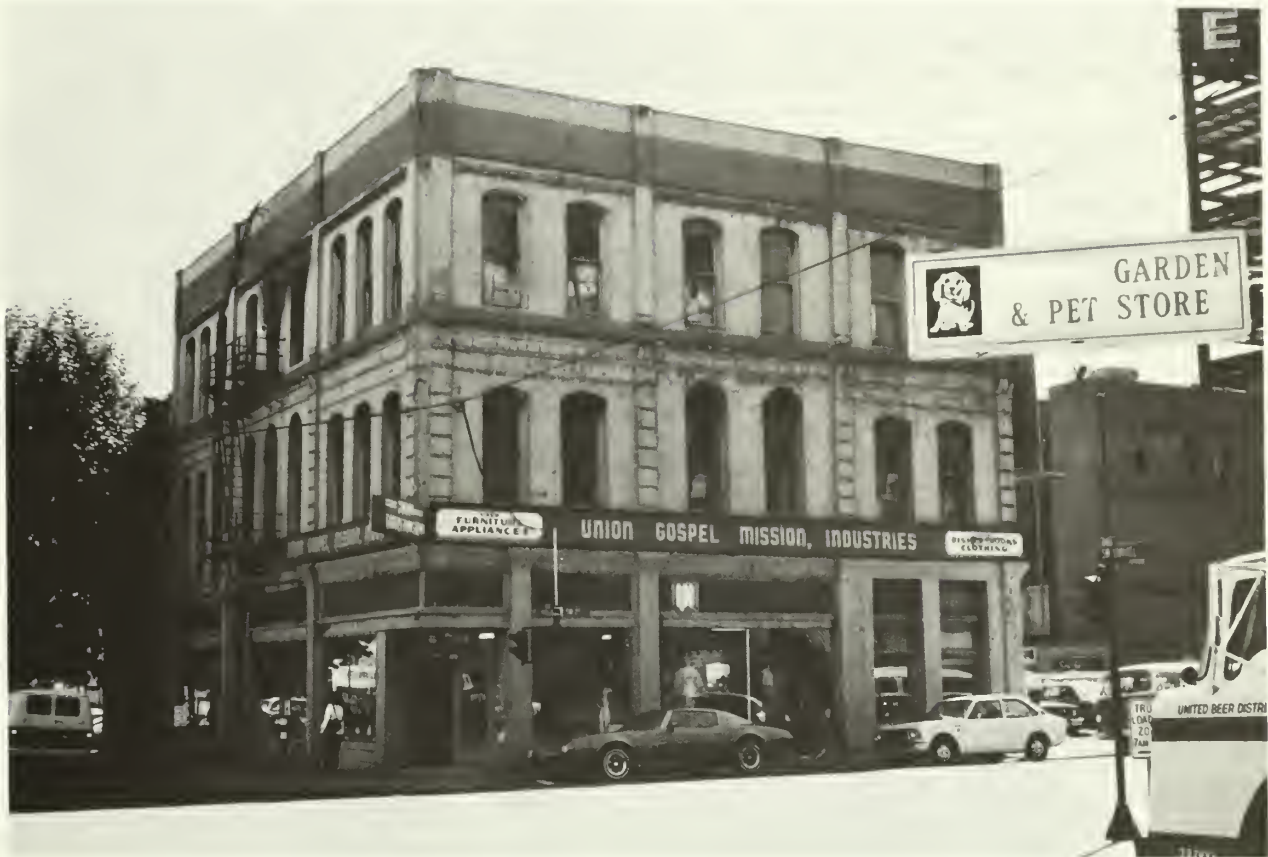
1. The building prior to rehabilitation was a three-story structure prominently located on a corner site in a National Register district noted for late 19th century commercial structures. Originally built in 1884 as a two-story brick building, a third floor was added in 1890, the building was stuccoed and an elaborate projecting cornice was applied. The cornice was lost in the mid-twentieth century and the building suffered a serious fire on the third floor prior to the rehabilitation.

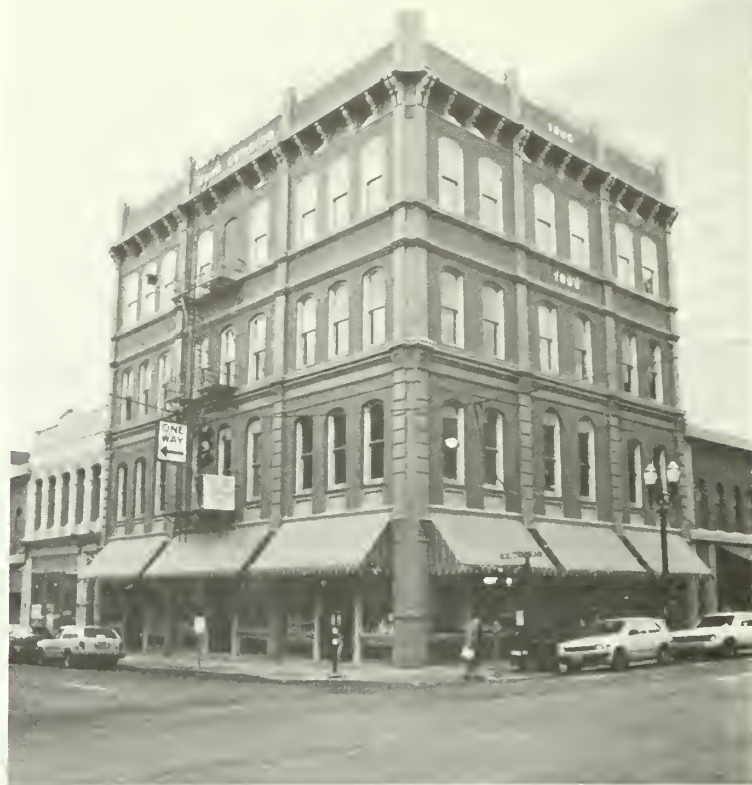
2. The historic building received a one and a half story addition to accommodate eight loft bedroom apartments over the retail and office space. Note the change in scale and the dramatic vertical emphasis as a result of the new rooftop addition. As the overall mass, scale and proportional relationships of the building were significantly altered, the project was denied certification.

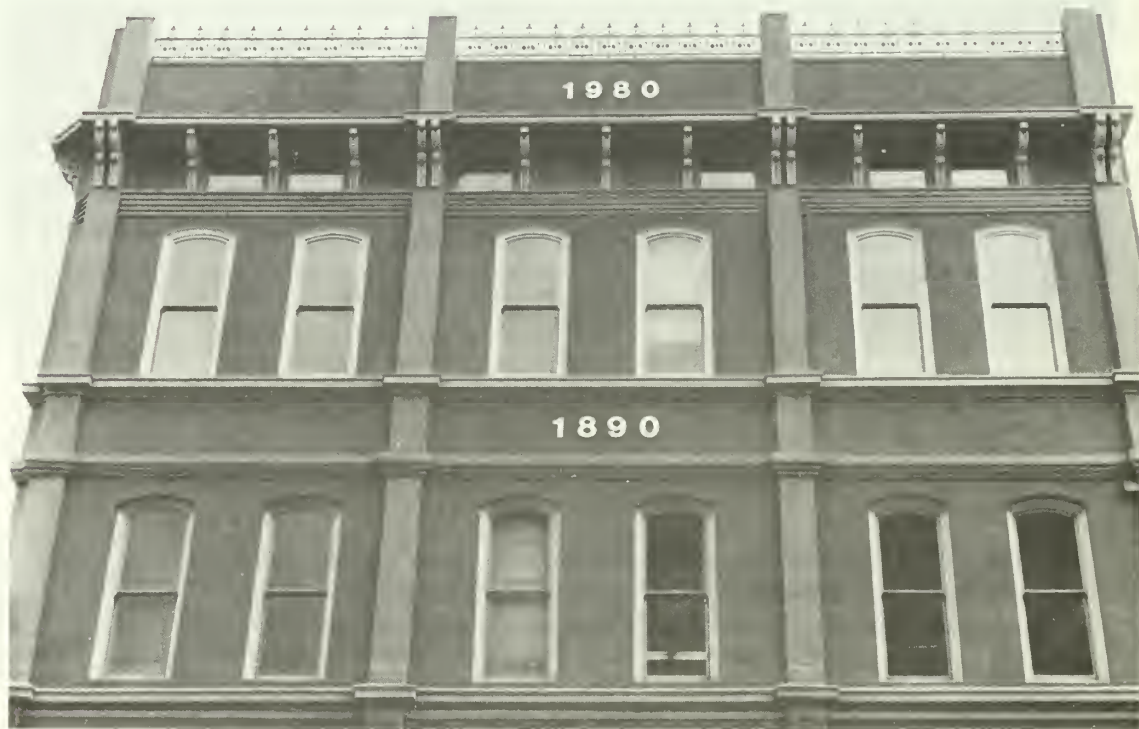
3. The new rooftop addition is not differentiated from the historic resource except by the use of applied dates. The addition is flush with the exterior walls and has adopted historicized features including wrought iron cresting, bracketed cornice, jack-arch windows, pilasters and beltcourses. In this case, however, the addition so altered the scale and massing of the building, that even if the addition had been contemporary in design, it could not have been certified.

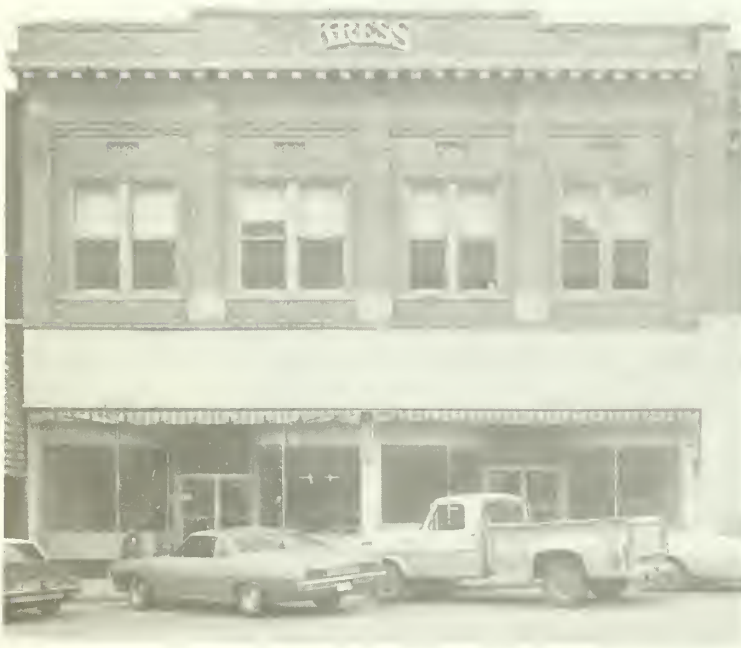
1. Prior to rehabilitation, the 1930s Kress Company storefront had survived in place with nice curved entrances although the transoms had been covered over.

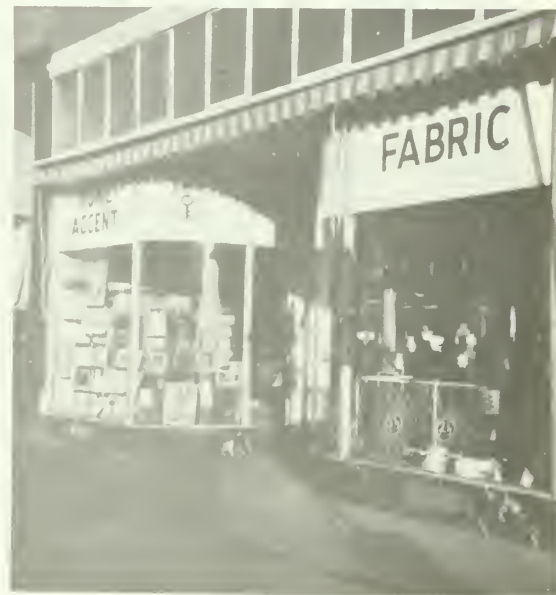
2. Very little change to the 1930s storefront had occurred prior to rehabilitation as evidenced by this historic photograph.

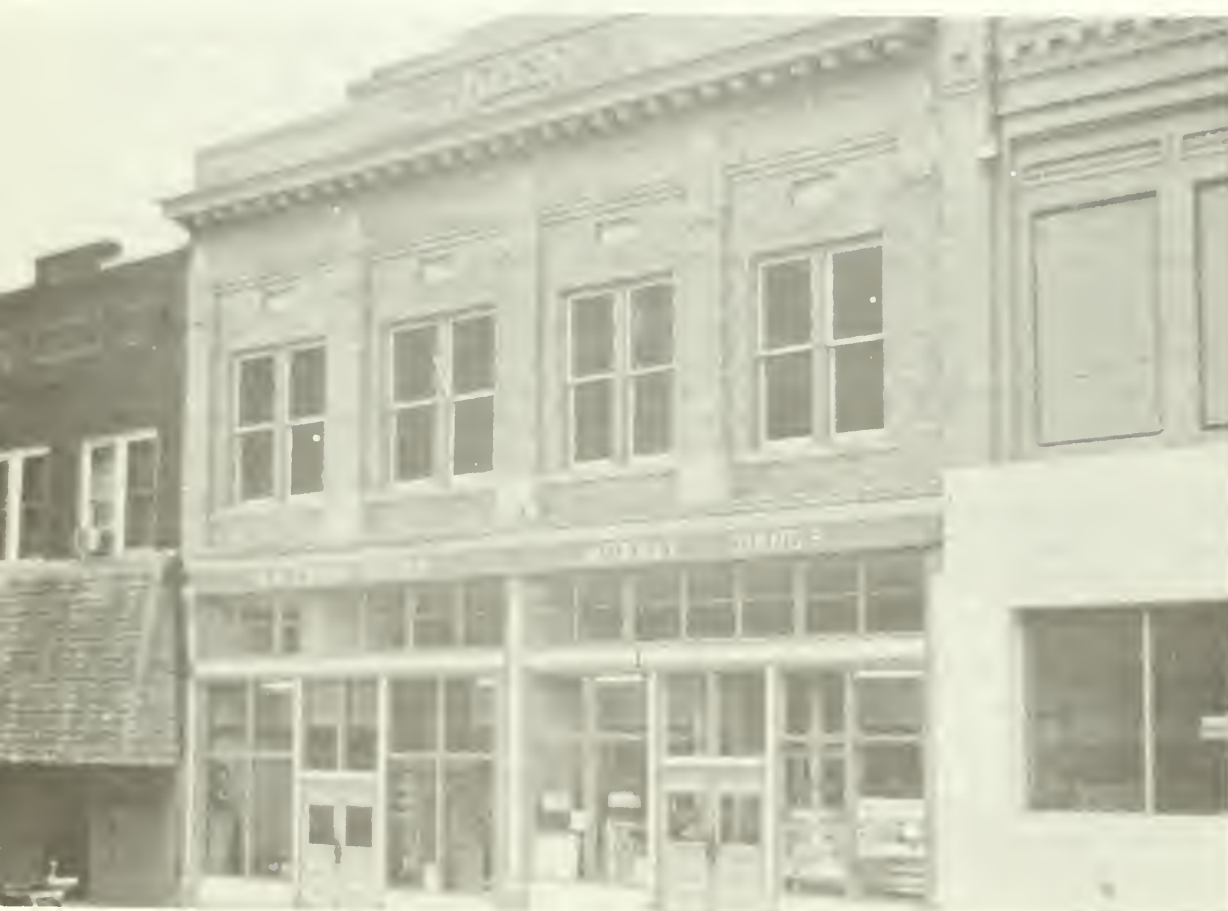
4. View of storefront after rehabilitation showing conjectural appearance of the original storefront — note inappropriate detailing of the transoms and small size of the doors.

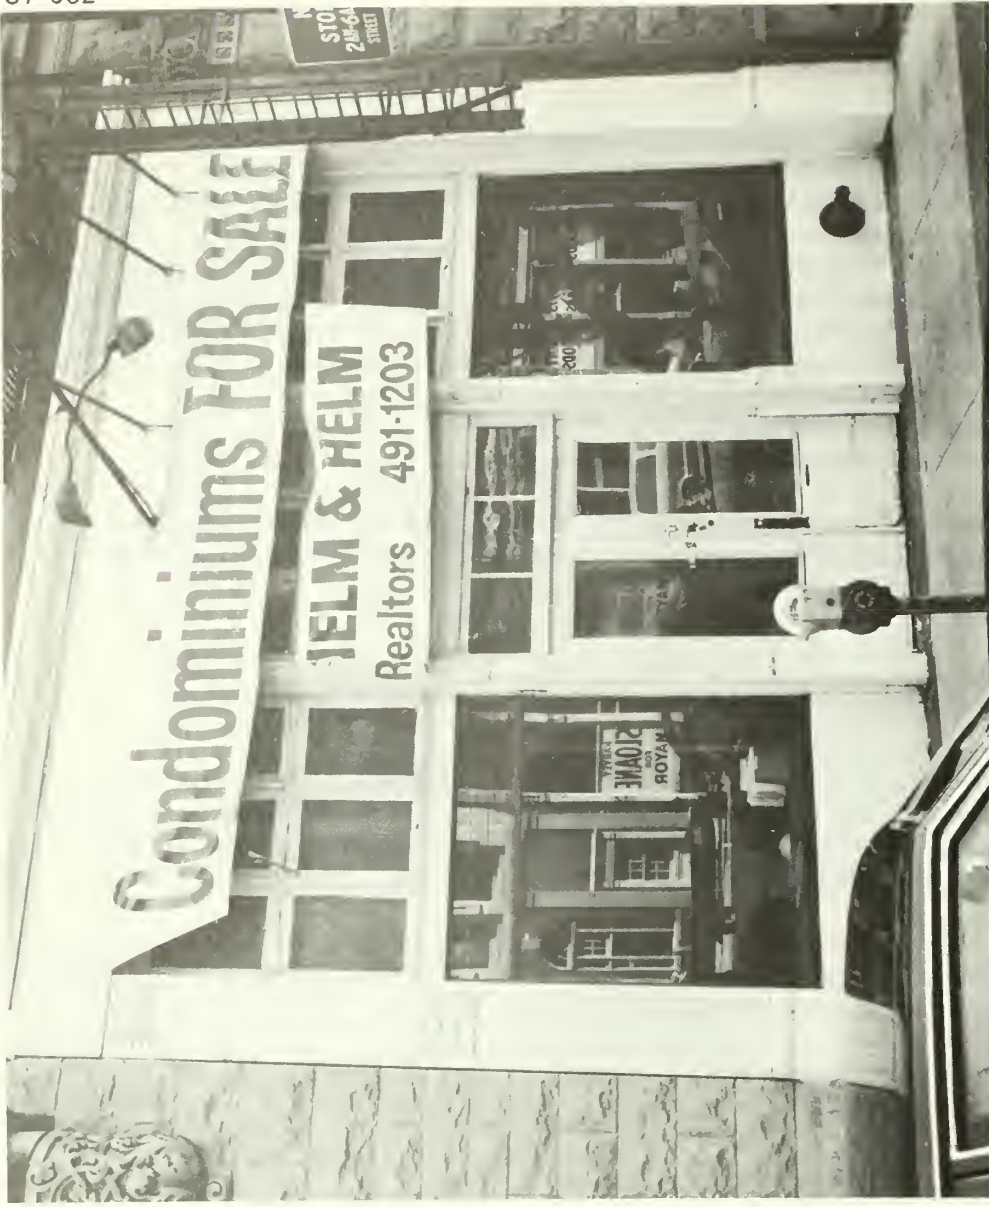
2. The owner removed the nonoriginal elements of the storefront, including plain concrete block kick panels beneath the display windows, standard non-decorative woodwork and glazing in the transoms and display window sash, and the unadorned double doors. Although the proposal was denied by the region, it was ultimately overturned on appeal. The Chief Appeals Officer concluded that the later storefront elements did not display any special significance, and could thus be removed. The original portions of the storefront--the distinctive cast-iron columns, pilasters, and cornice--were retained, preserved, and integrated into a compatible, contemporary storefront design.

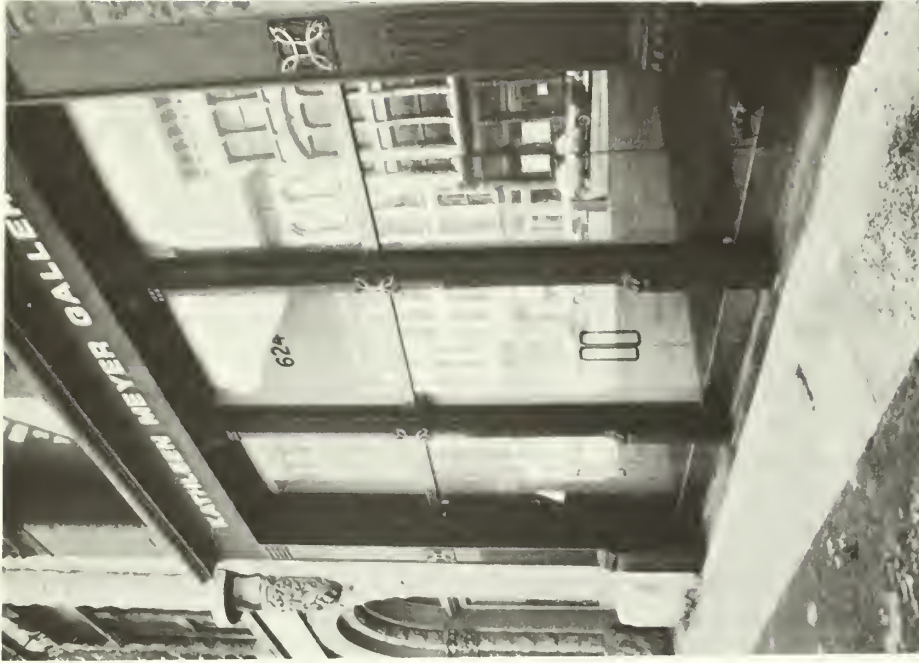
3 and 4. Overall and detail views, after installation of the compatible new storefront features. Note the 1930s-1940s features have been replaced, while the new design successfully retains the 3-bay division defined by the decorative cast-iron columns and cornice. The original cast-iron storefront elements have been painted dark brown as well as upper level window trim and cornice.

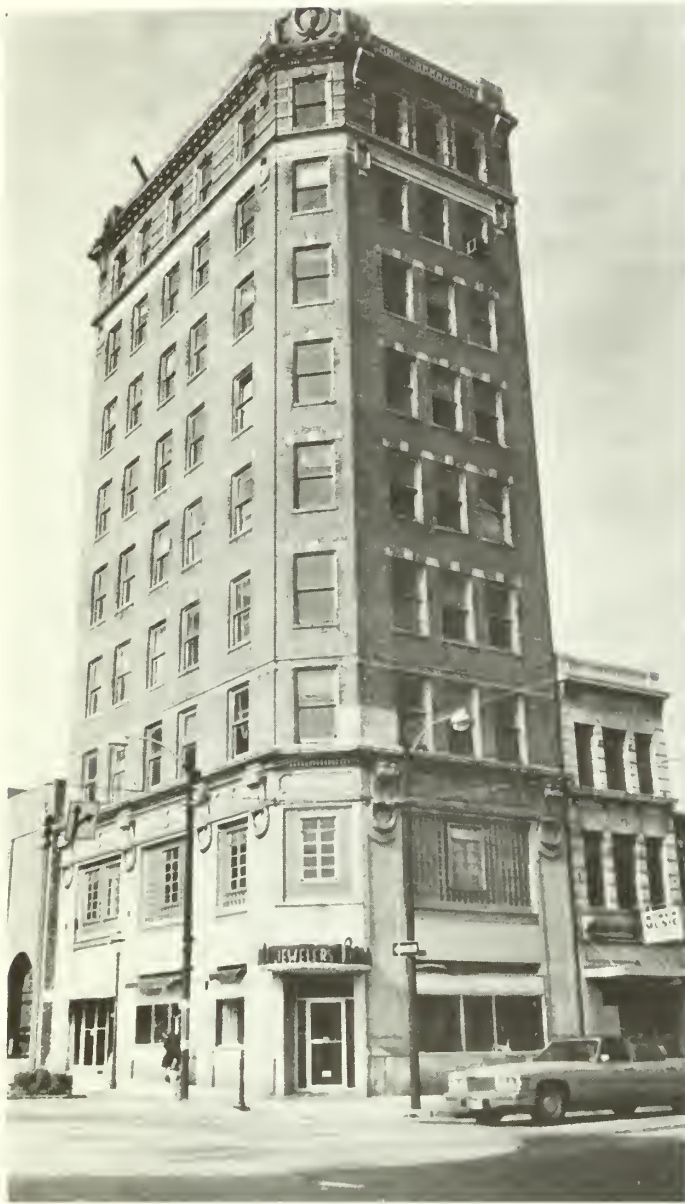
1. Nine story bank and office building before rehabilitation. Note uniformity of brick color.

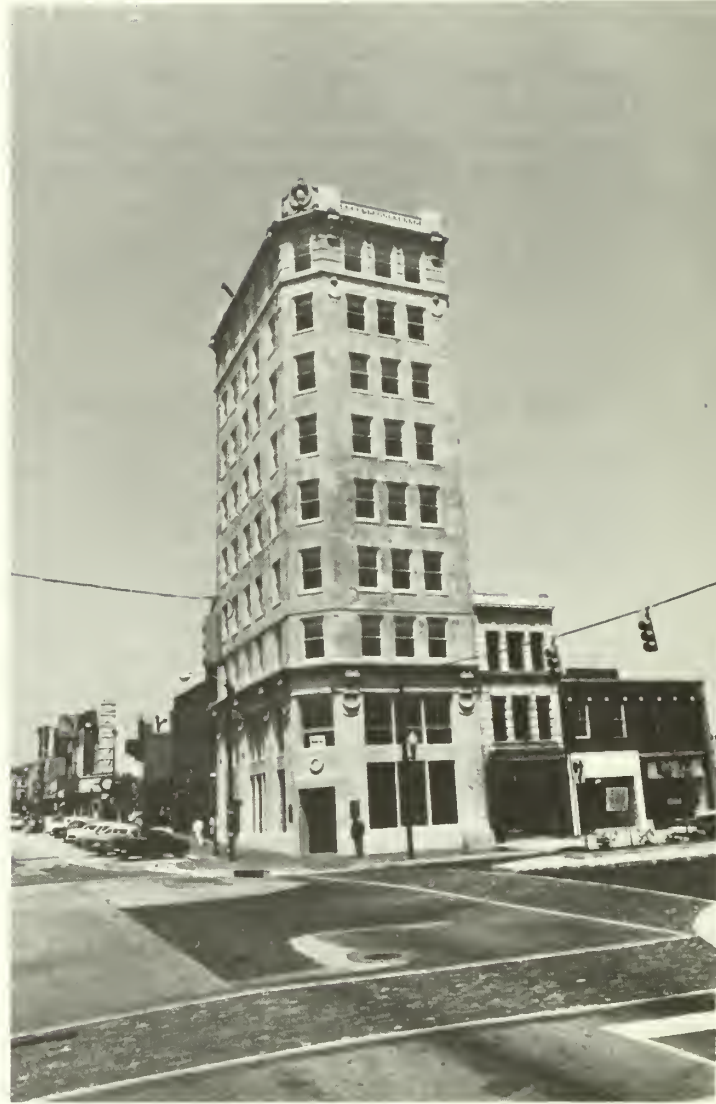
2. Office building after chemical cleaning showing splotchy and discolored brick.

When the completed project was submitted to the National Park Service for final review, however, it was denied certification on the basis of the cleaning techniques which had resulted in "severe discoloration and splotching of the brick surfaces" (see illus. 2). The region's denial letter went on to say: "The brick was apparently cleaned with an inappropriate chemical cleaner which was not adequately tested before its use, contrary to the recommendations contained in the Secretary's Guidelines for Rehabilitating Historic Buildings. Although the physical damage to the brick was not documented, the region felt that the visual change to the brick surface was sufficient to deny the project, citing violation of Standards 7 and 2.

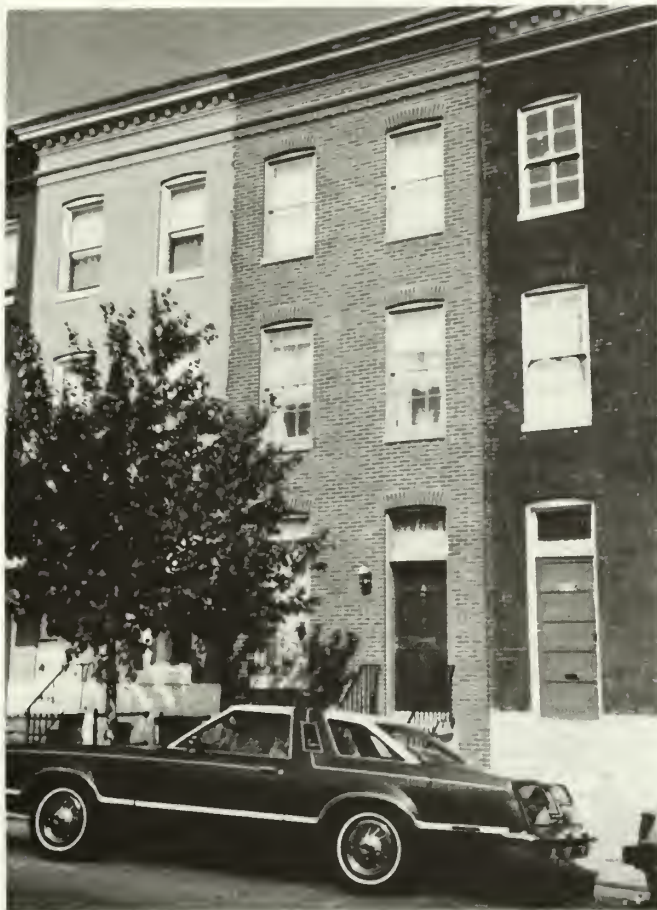
3. Brick rowhouse in center after paint removal using sodium hydroxide stands out conspicuously from its still painted neighbors.

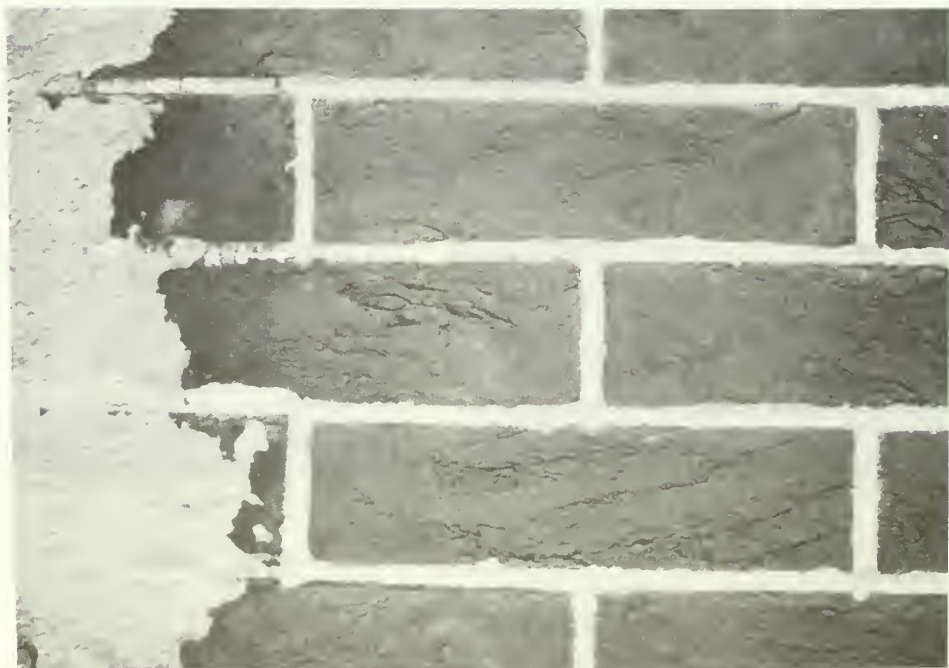
5. Close-up view of chemically cleaned brick showing deep ridges and newly abraded texture.

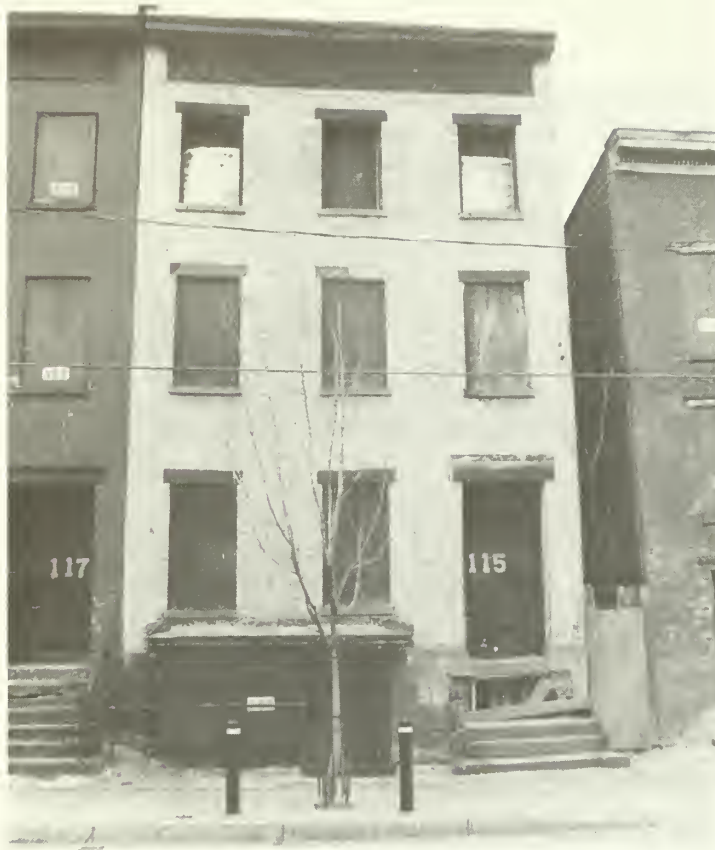
1. Although photographic documentation submitted with the Part 1 application showed some deterioration and loss on the primary elevation, NPS determined that the building exhibited sufficient "integrity" to qualify as a certified historic structure.

Application: A deteriorated, three-story, three-bay wide brick structure built in 1843 was certified in the Part 1 application as contributing to the significance of the registered historic district--a 13 block area of 19th century Federal and Greek Revival structures (see illus. 1,2,3,4).
